**Evaluation of Unpainted Weathering
Steel Bridges in Idaho**

**FINAL REPORT
FHWA-ITD-RP117**

Richard A. Jobes, PE

August 1, 1996

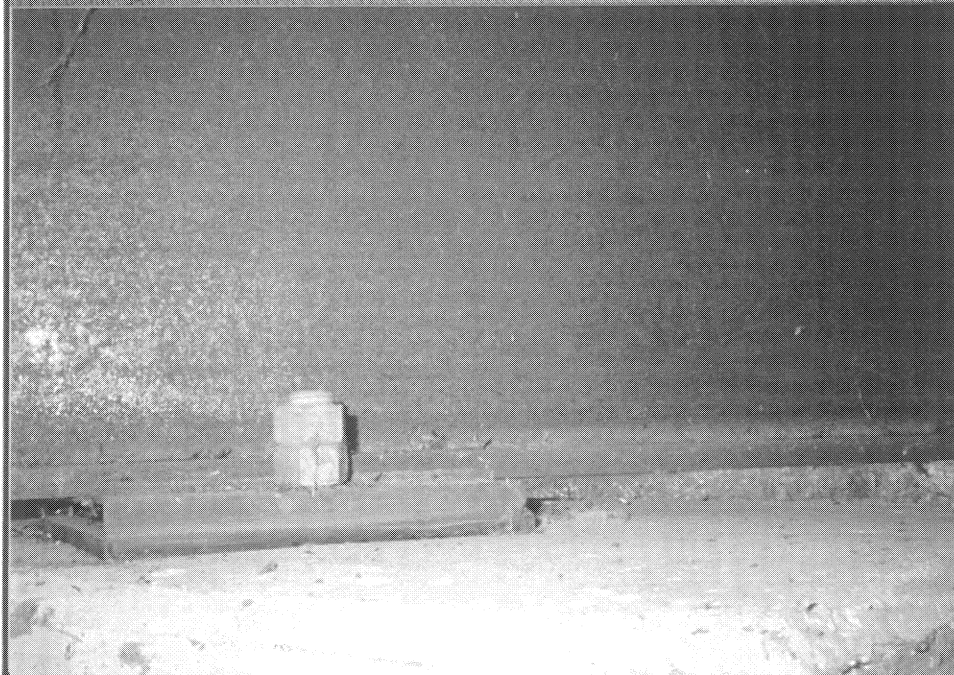
Photo No. 68
View of fixed bearing at
the pier.

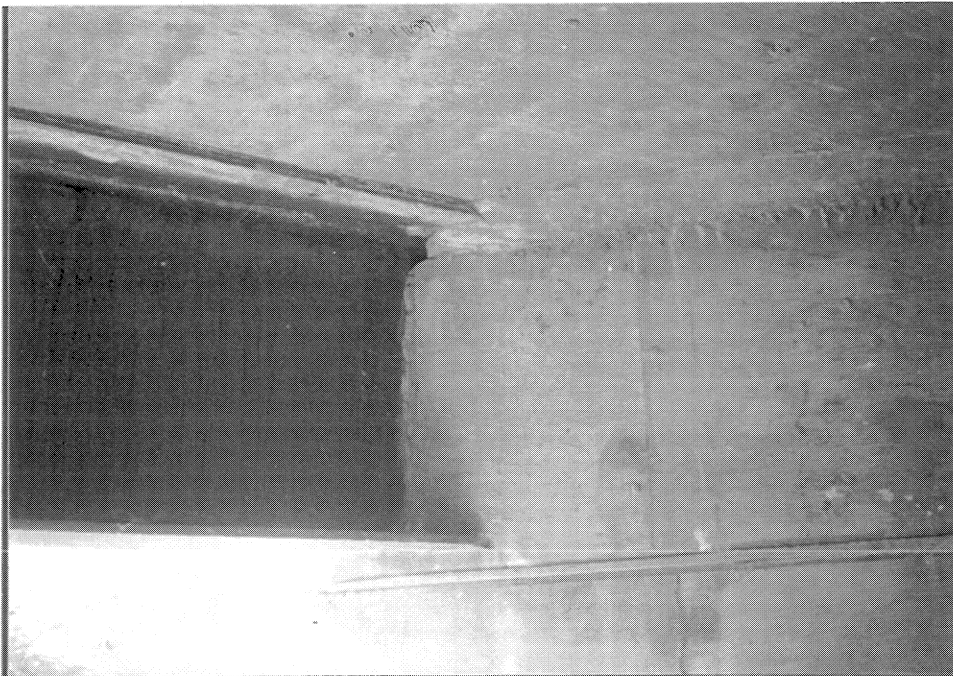
Photo No. 69
Interior view of girder at
the North Abutment.
Note fixed condition.

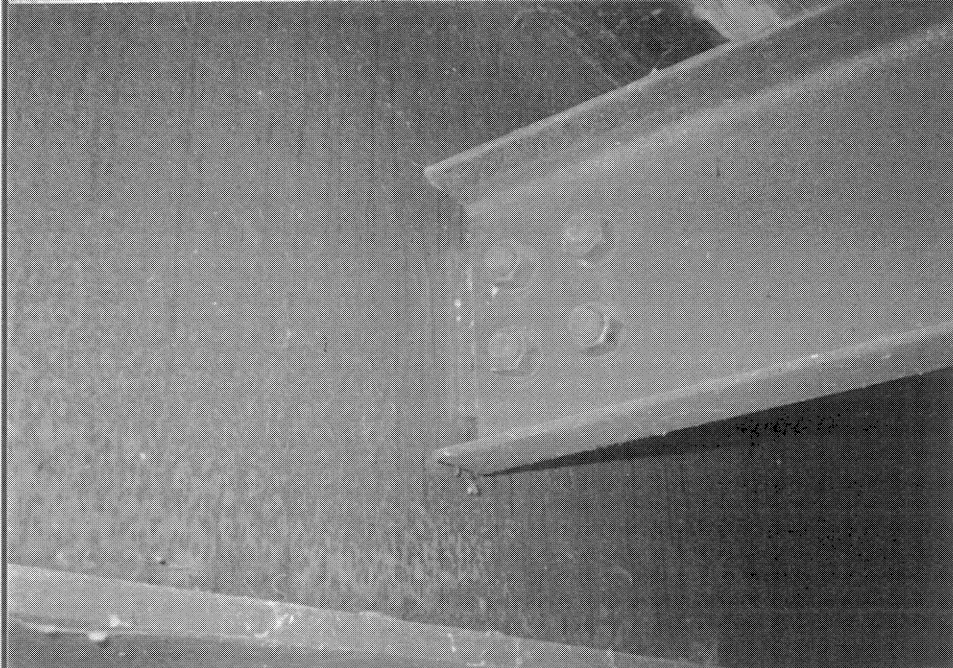
Photo No. 70
View of intermediate
diaphragm connection.

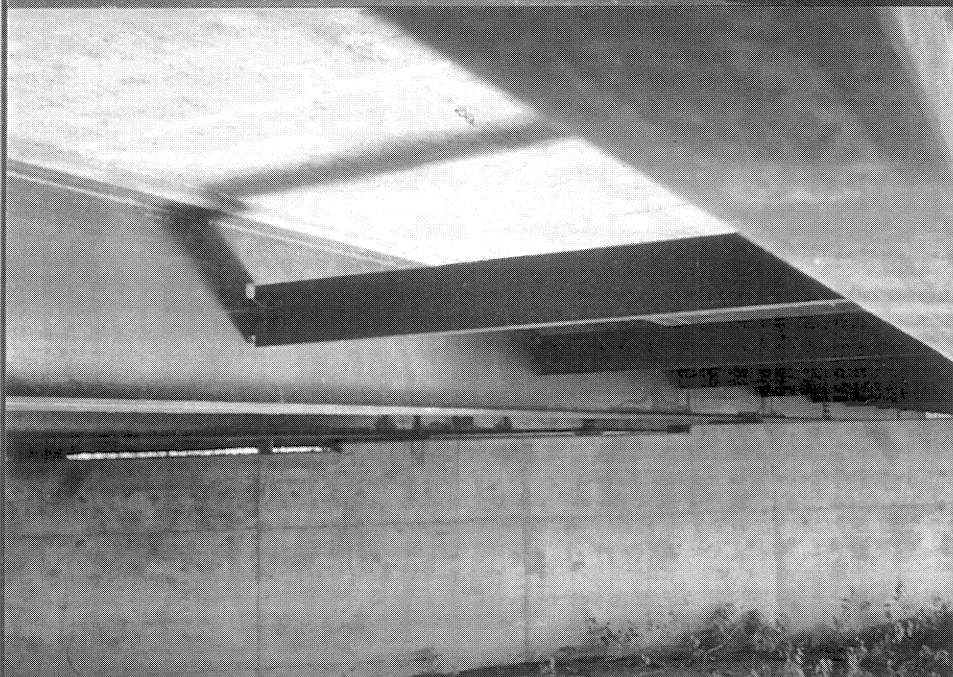
Photo No. 71
View of pier and
underside of bridge.

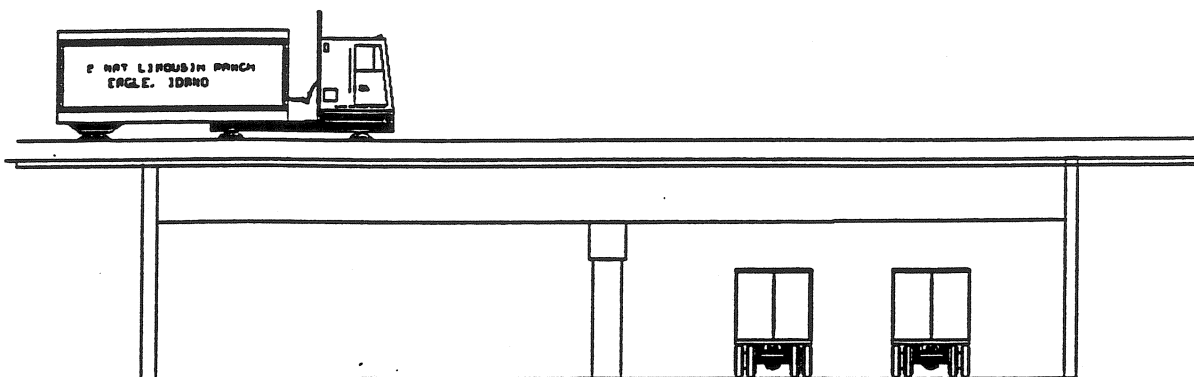
Figure 1 DEPRESSED ROADWAY TUNNEL EFFECT

- (1) Grade Separations - The so-called "tunnel effect" is produced by the combination of narrow depressed roadway sections between vertical retaining walls, narrow shoulders, bridges with minimum vertical clearances and deep abutments adjacent to the shoulders as are found at many urban/suburban grade separations. These roadway/bridge geometrics combine to prevent roadway spray from being dissipated by air currents and can result in excessive salt in the spray being deposited on the bridge steel. Figure 1 shown below is representative of situations where use of uncoated weathering steel should be avoided where winter deicing salt use is significant.
